LIVING HISTORY

Once home to Henry and Clara Ford, Fair Lane is undergoing a restoration of epic proportions.

BY KILEY JACQUES

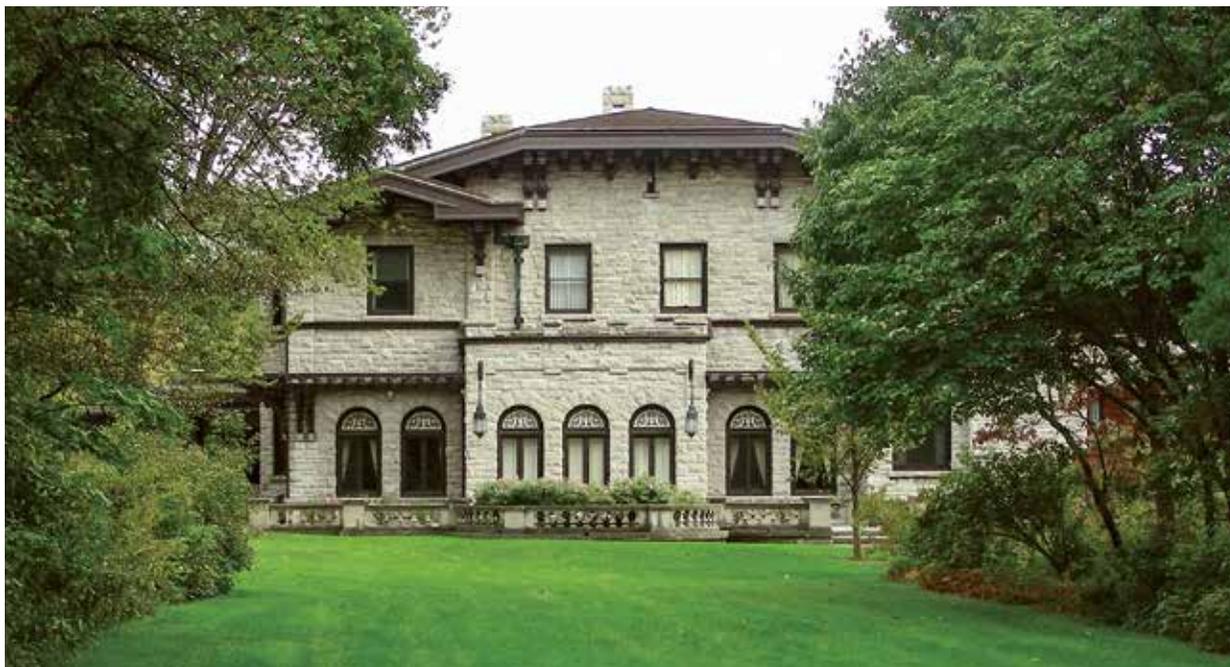
TOP: Henry and Clara Ford completed their 31,000-square-foot dream house called Fair Lane in 1915. Photo by John F. Martin.

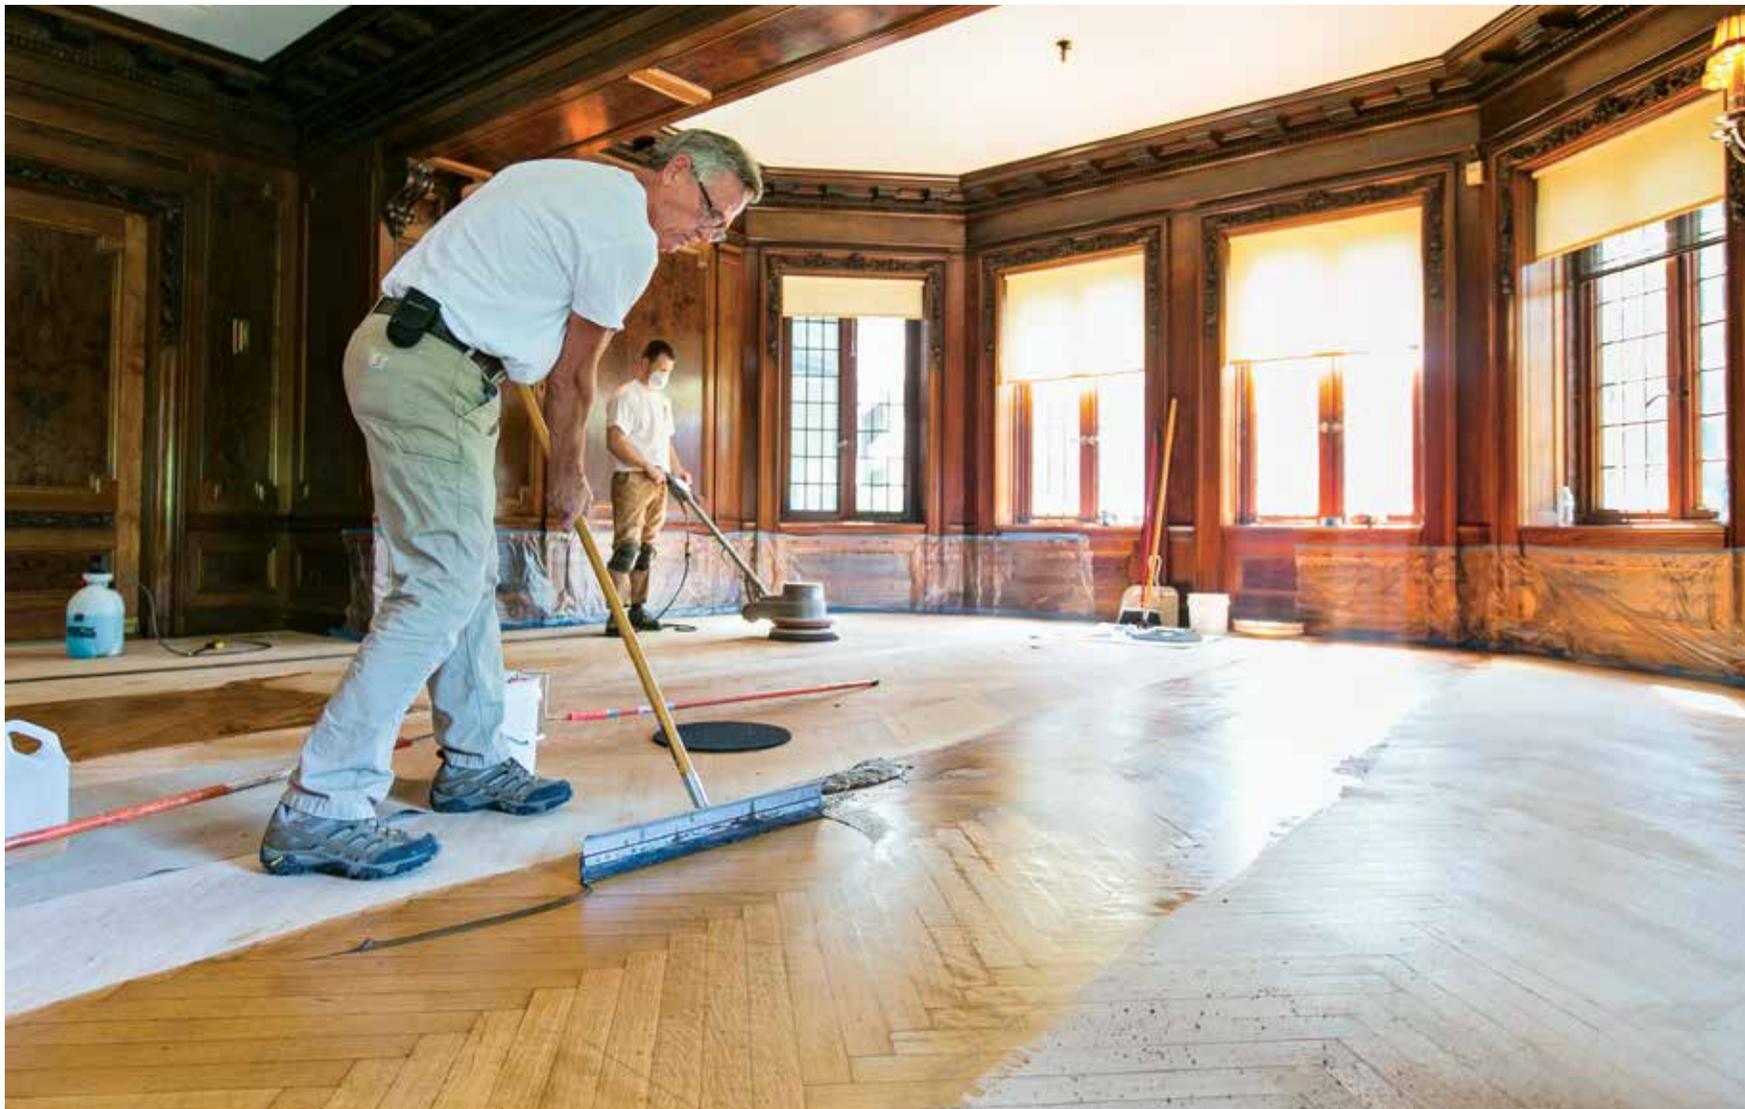
OPPOSITE TOP: Conservators from Atlanta, Georgia-based Rosebud Company are working to restore the estate's more than 13,740 square feet of aged oak floors using a passive refinishing process. Photo by John F. Martin.

Forging relationships with the right tradespeople also makes it possible to employ best practices. Heppner cites the example of a hardwood floor restoration expert who uses a passive refinishing technique to remove layers of stain and wax to reveal the original floors, which he then treats with oils used at the time they were laid. "The history and heritage are in the wood floors, and by sanding them you lose all that history, and you are weakening the floor," Heppner explains, adding that, were it not for that expert input, they surely would have sanded the floors.

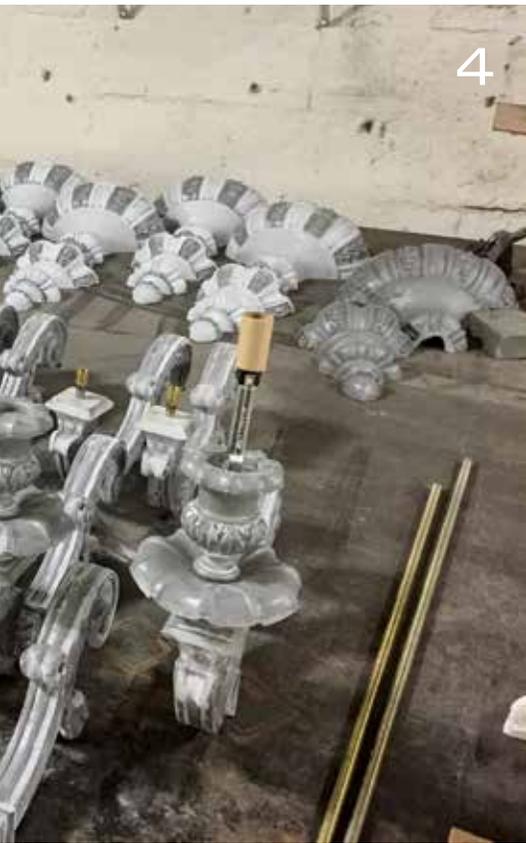
4

4: Sconce arms for the music room were created by Heritage Metalworks. They were cold cast to pick up carving texture of original bobeches and bodies - after pattern work and casting but prior to adding a painted finish. Photo by John F. Martin.

Reconstituting the cold-cast and gilded music room scones and wrought-iron smoking stands required a mix of techniques. In some cases, the team used 3-D printing to form design plans; other times, hand sculpting was used. Pieces were cast using the lost wax process, which can pick up highly refined details, and is effective for lending a feeling of age.

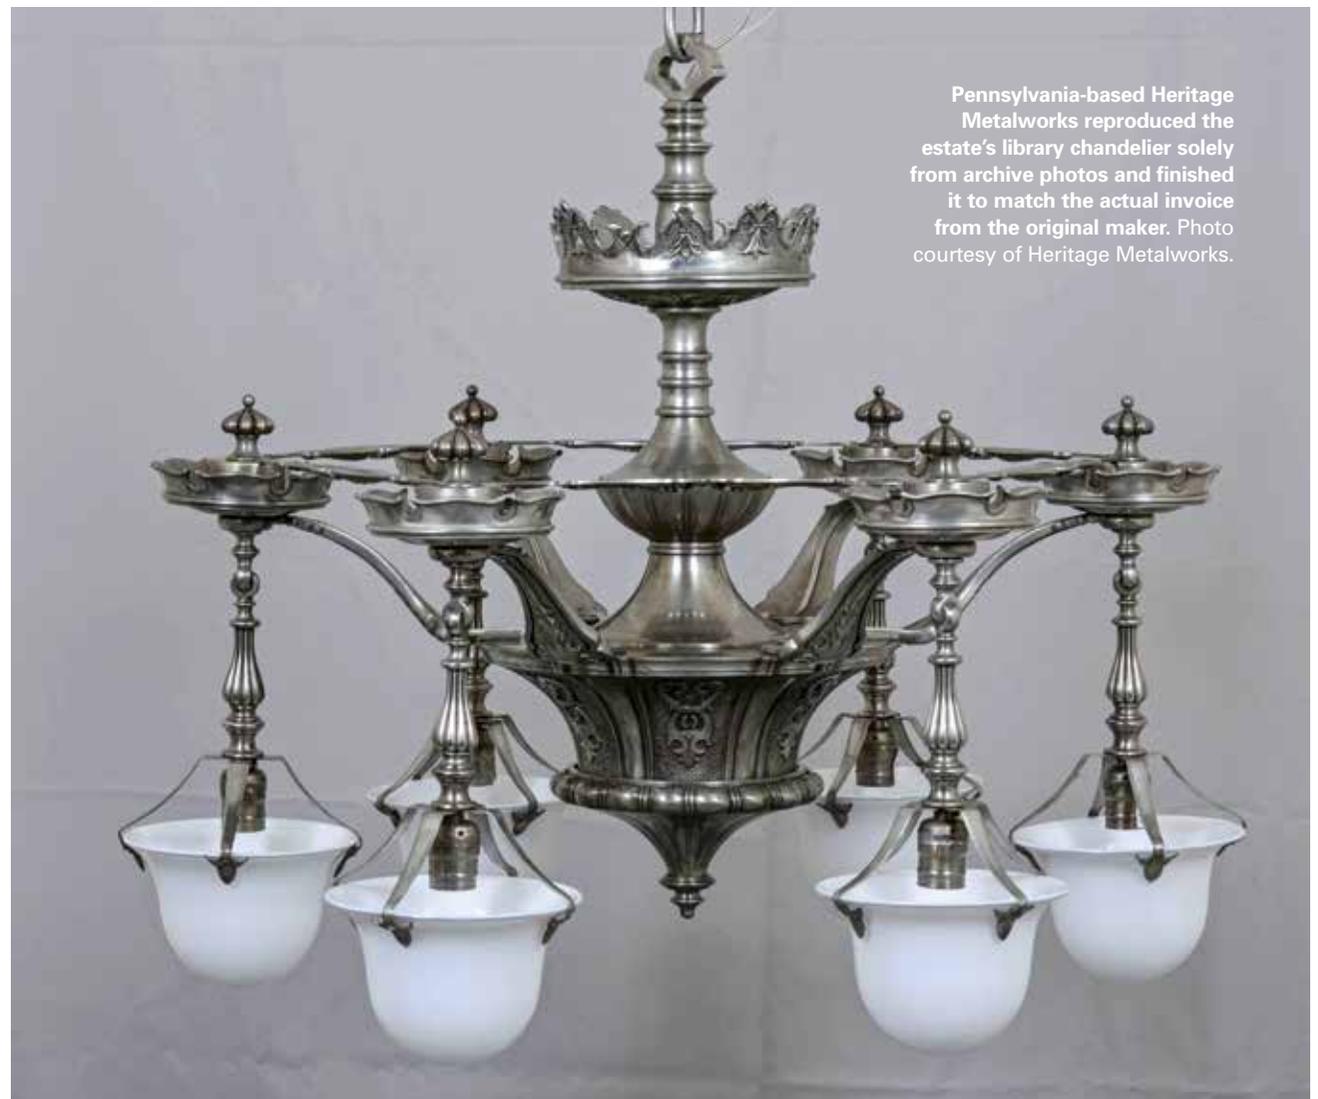
Pennsylvania-based Heritage Metalworks reproduced the estate's library chandelier solely from archive photos and finished it to match the actual invoice from the original maker. Photo courtesy of Heritage Metalworks.

often specified finishes. Additionally, by referencing millwork, molding, plaster work, and other key points in the library, they were able to determine the size of a missing chandelier and scones. It's this kind of sleuth work that makes the project so demanding and rewarding.

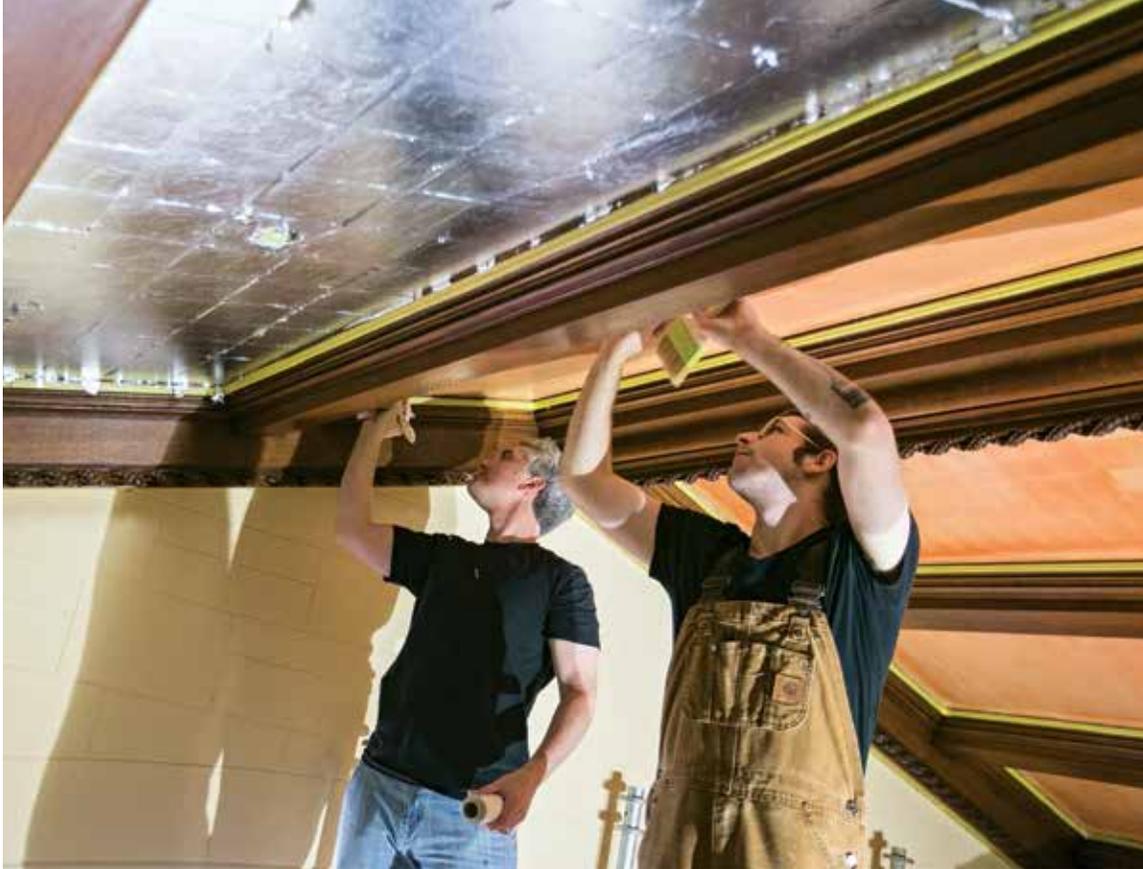
COUNTER-CLOCKWISE FROM ABOVE: Artisans from Historic Surfaces LLC apply aluminum leaf to the ceiling in Fair Lane's main hall. Photo by John F. Martin.

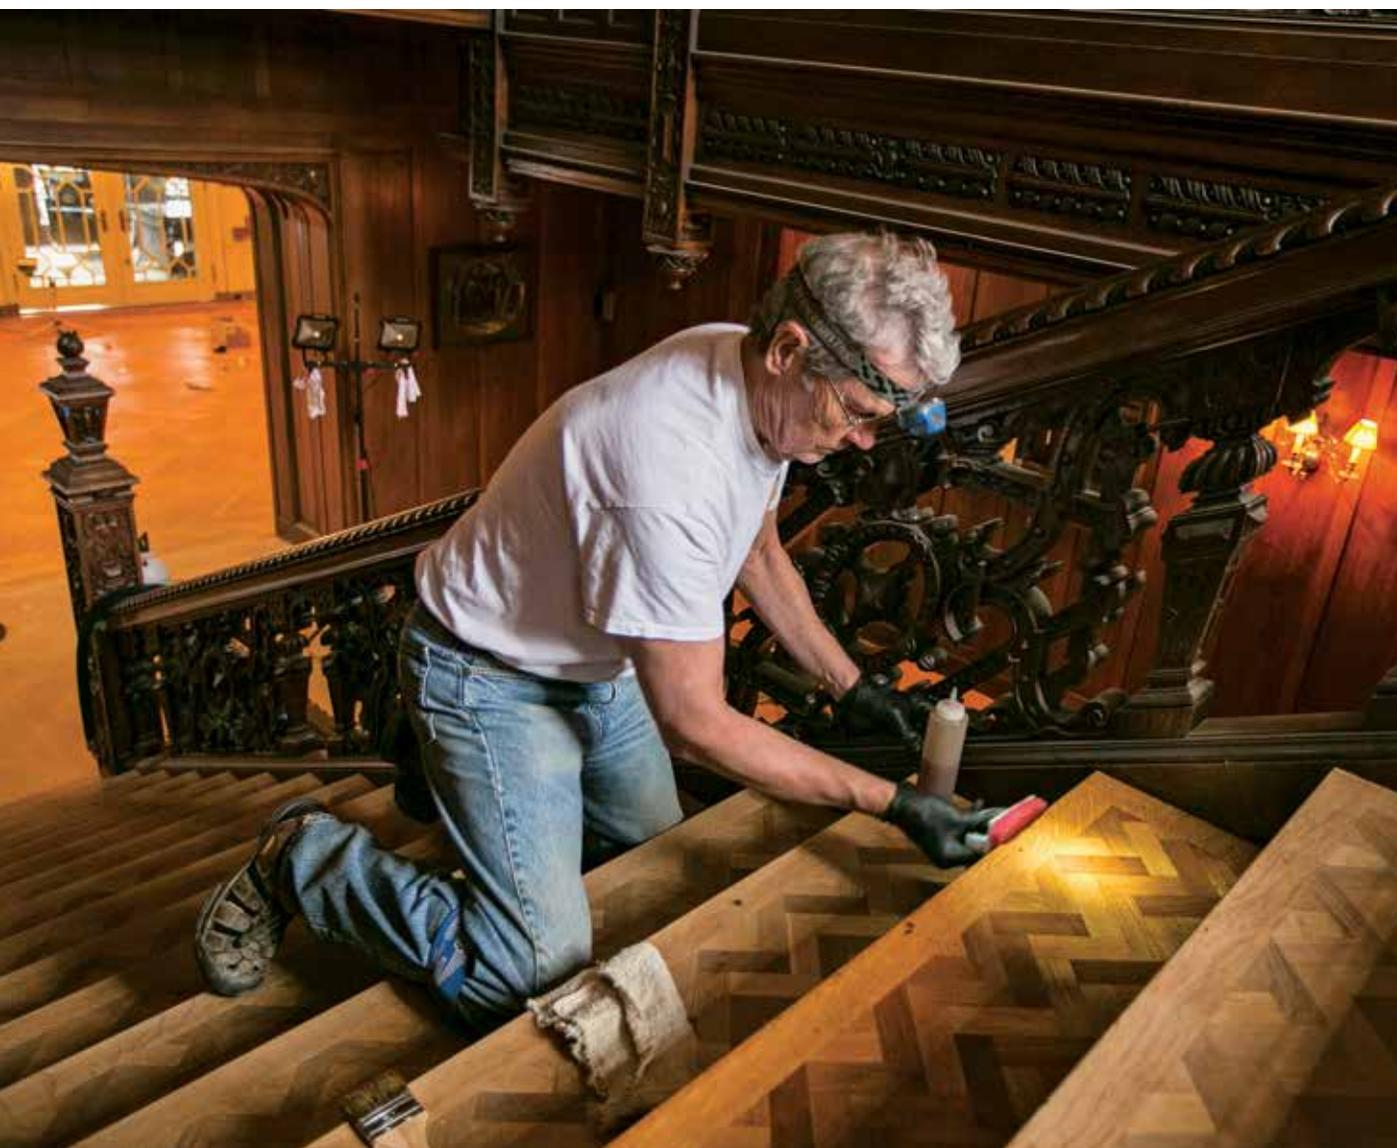
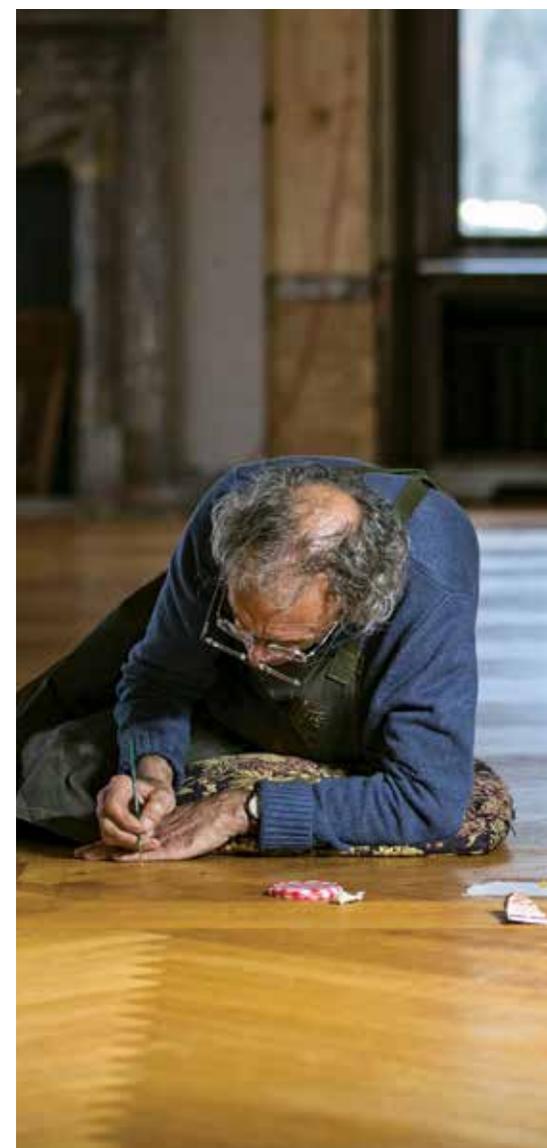
Fair Lane's white oak floors were laid in a herringbone pattern, including staircases and closets. Photo by John F. Martin.

Conservator Mark Gervasi performs detailed repairs to Fair Lane's floors. Photo by John F. Martin.

Conservators work to repair the wood floors in between Fair Lane's living and dining rooms. Photo by John F. Martin.

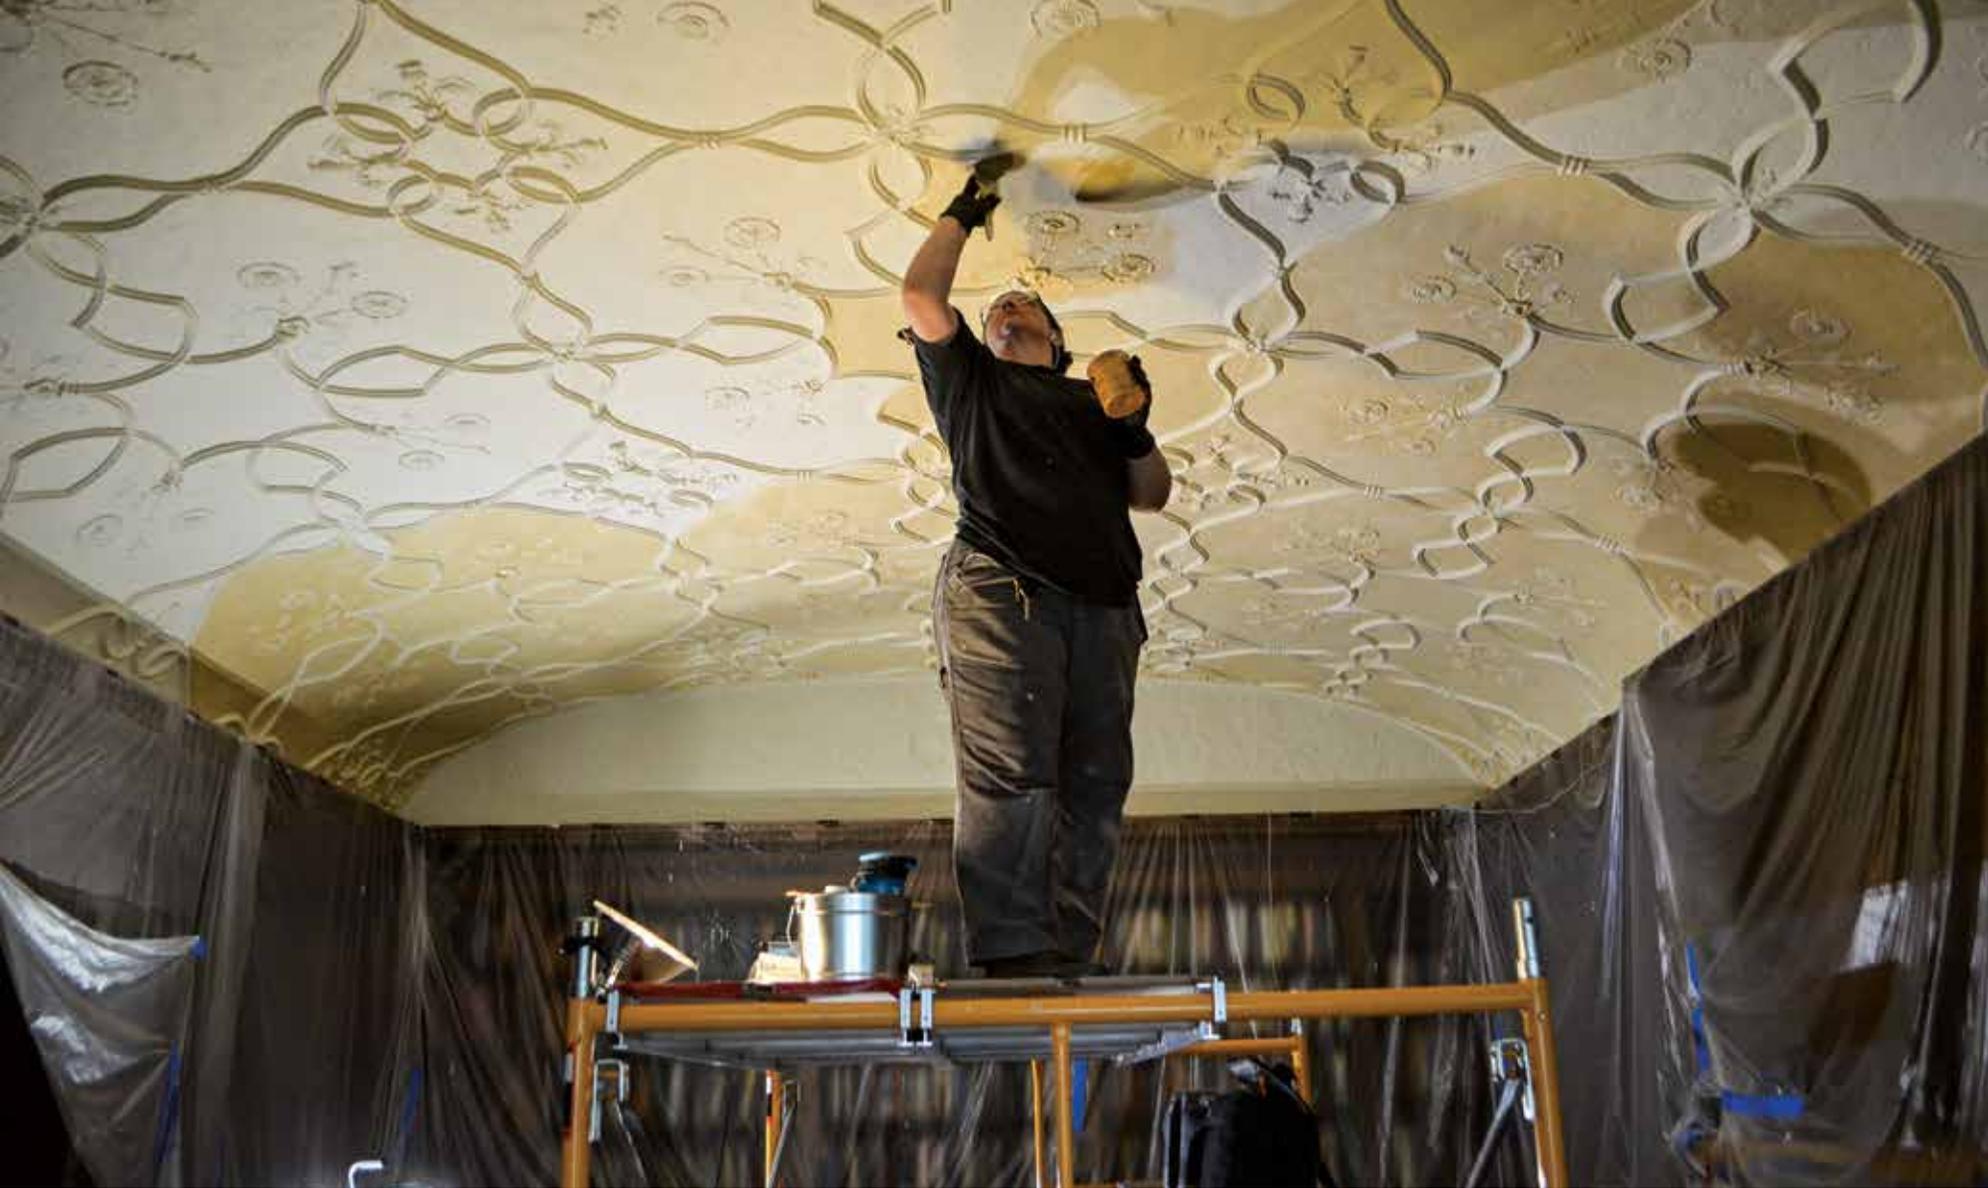
Historic Surfaces LLC worked to remove layers of cream paint from the ceiling, stabilize and repair the plaster, and refinish it with a beautiful glazing to match the original that Henry and Clara commissioned to complement the rich wood walls. Photo by John F. Martin.
